***Field Service Bulletin***

**Flare Fittings and the Integrated Mixing Device**

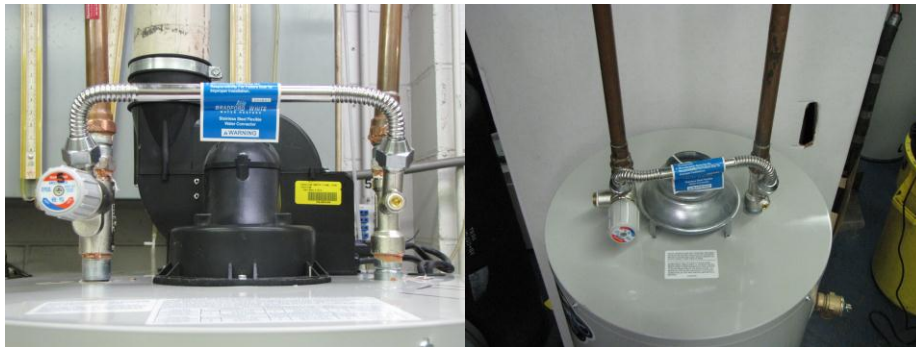
A small water leak from the IMD flare fitting joint could be duplicated if the IMD sealing faces were damaged, the tube/adaptor sealing faces were misaligned, and/or improper torque was applied to the flare nut. The leak could be eliminated by correcting the variables above.

Below left is an example of what a properly installed, leak free, IMD should look like with flex tube straight and plumb, while the example below right shows the flex connector bent indicating the fitting nut may be too tight and could benefit from lubrication.

An installation suggestion is to use a small amount of lubricant, such as a non-gritty pipe dope, on the mating surfaces. The lubricant allows the tube adapter/sealing faces to properly align with each other and ensures the fittings are square when torque is applied to the fitting nut. Be sure not to over-tighten the flare nut.
