Atmospheric and Direct Vent Water Heaters - ICON 2.0
Serial Date Code "TA" (Jan 2019) and Later*

Atmospheric and Direct Vent Water Heaters - ICON 1.0 Serial Date Code "TA" (Jan 2019) and Prior*

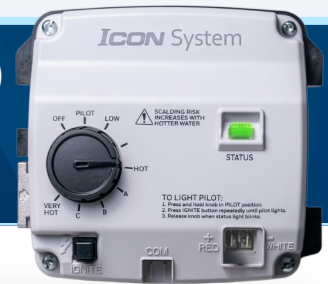
Error Code	Definition	Service Action	Possible Parts Needed
No LED	No pilot light / heater not in operation	Follow lighting instructions on the water heater	1) None
One flash & four second pause	Knob in pilot position or thermostat satisfied	None	1) None
One flash every second	Thermostat calling for heat	None	1) None
Two flashes & three second pause	Weak pilot signal detected	Verify pilot is lit Check thermopile voltage output Check wire connections at gas valve	1) Pilot assembly 2) Gas valve
Four flashes & three second pause	High tank temperature	Check temp probe ohms Check if tank temperature exceeds setpoint Verify no heat migration in plumbing system	1) Gas valve cover w/ temp probe 2) Gas valve
Five flashes & three second pause	Thermostat sensor fault	Check temp probe ohms/ensure tight connection Replace gas valve	1) Gas valve cover w/ temp probe 2) Gas valve
Six flashes & three second pause	Tank leakage detected by accessory module	Refer to troubleshooting for the accessory module	1) Refer to troubleshooting for the accessory module

Solid ON	Not an error-indicates that the control is shutting down Control Knob turned to the off position	None; wait until LED goes out before attempting to relight	1) None
NOTE:	Check all wire connections Check gas inlet and manifold gas pressure Check for grounding connections

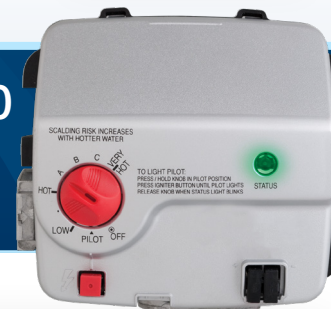
Error Code	Definition	Service Action	Possible Parts Needed
No LED	No pilot light / heater not in operation	Follow lighting instructions on the water heater	1) None
One flash & three second pause	Knob in pilot position or thermostat satisfied	None	1) None
LED Strobe (two quick flashes) & three second pause	Thermostat calling for heat	None	1) None
LED on continuously	Control knob turned to the off position	Wait for LED to go off before relighting	1) None
Two flashes & three second pause	Weak pilot signal detected	Verify pilot is lit Check thermopile voltage output Check wire connections at gas valve	1) Pilot assembly 2) Gas valve
Three flashes & three second pause	Gas valve has not seen temp rise in proper amount of time	Check temp probe ohms	1) Gas valve cover w/ temp probe
Four flashes & three second pause	High tank temperature	Check temp probe ohms Check if tank temperature exceeds setpoint Verify no heat migration in plumbing system	1) Gas valve cover w/ temp probe 2) Gas valve

Five flashes & three second pause	Thermostat sensor fault	Check temp probe ohms/ensure tight connection Replace gas valve	1) Gas valve cover w/ temp probe
Six flashes & three second pause	Water leak detected by the accessory module (if installed)	Refer to trouble shooting for the accessory module	1) Refer to troubleshooting for the accessory module
Seven flashes & three second pause	Gas valve fault	Reset gas valve if problem persists replace gas valve	1) Gas valve
Eight flashes & three second pause	Pilot remains lit while the control knob is in off position	Check gas pressure Replace gas valve	1) Gas valve
NOTE:	Check all wire connections Check gas inlet and manifold gas pressure Check for grounding connections
